Inspector's Daily Report

IDR Sheet	1	of	5	Sheets
Contract	Day	Date			
C-7852	Friday	August 13, 2010

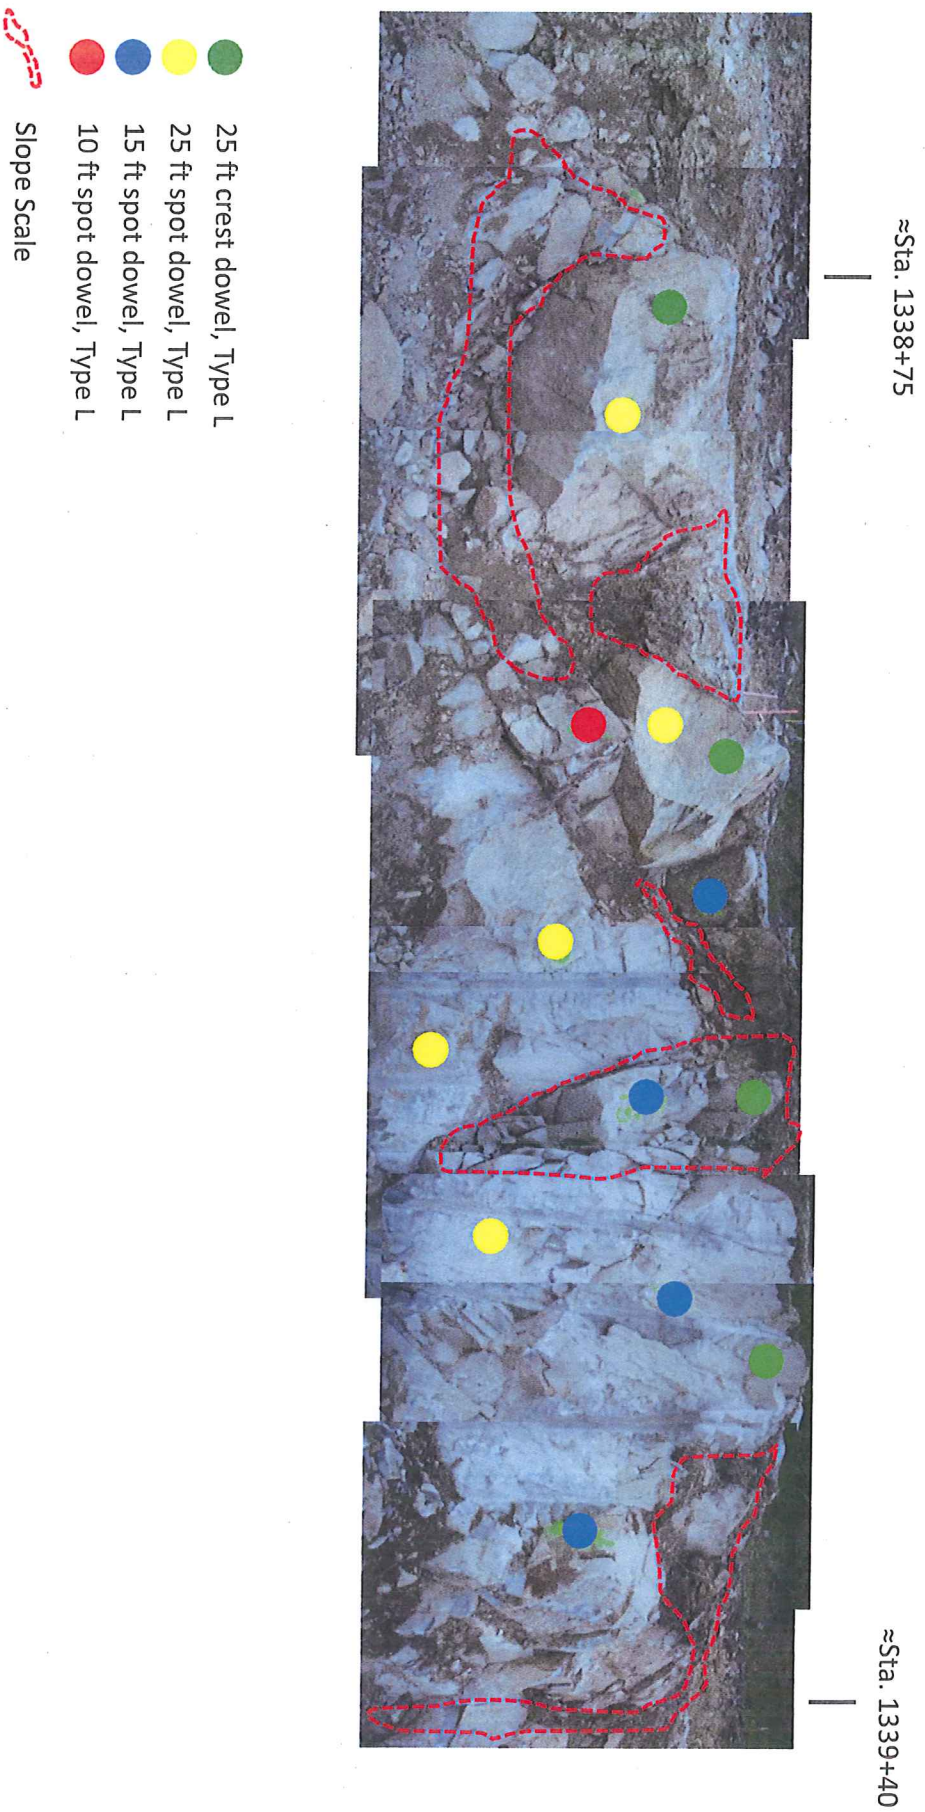
Stabilization Plan Between Stations 1338+75 & 1339+40

I arrived at the project site around 7:30 a.m. and took additional photos (looking straight on) of the cut face between Stations 1338+75 and 1339+40. I phoned Steve Lowell and asked him for comments on the preliminary stabilization plan I had e-mailed him the night before (see Marc Fish IDR 8/12/10). To assist in developing final recommendations, Steve e-mailed me the project cross sections so I could check the depths of the preliminary dowels to ensure they get behind a roadway dipping plane (38/211). He also stated that the crest dowels need to be installed up to the approximate Station 1339+40 as stated in the contract documents. I stitched the new photos together and started to develop a draft stabilization plan based upon geologic structure, removing and/or reinforcing potentially unstable blocks, and installing crest dowels. Later in the morning I e-mailed my draft recommendations to Steve, which consisted of four 25 ft Type L crest dowels, five 25 ft Type L spot dowels, four 15 ft Type L spot dowels, one 10 ft Type L spot dowel, and several small areas of slope scaling. Steve commented on my draft recommendations and suggested that the slope scaling areas should be expanded. I incorporated Steve's comments into the final recommendations and e-mailed our final stabilization plan to Will Smith around 12:00 p.m. (Figure 1).

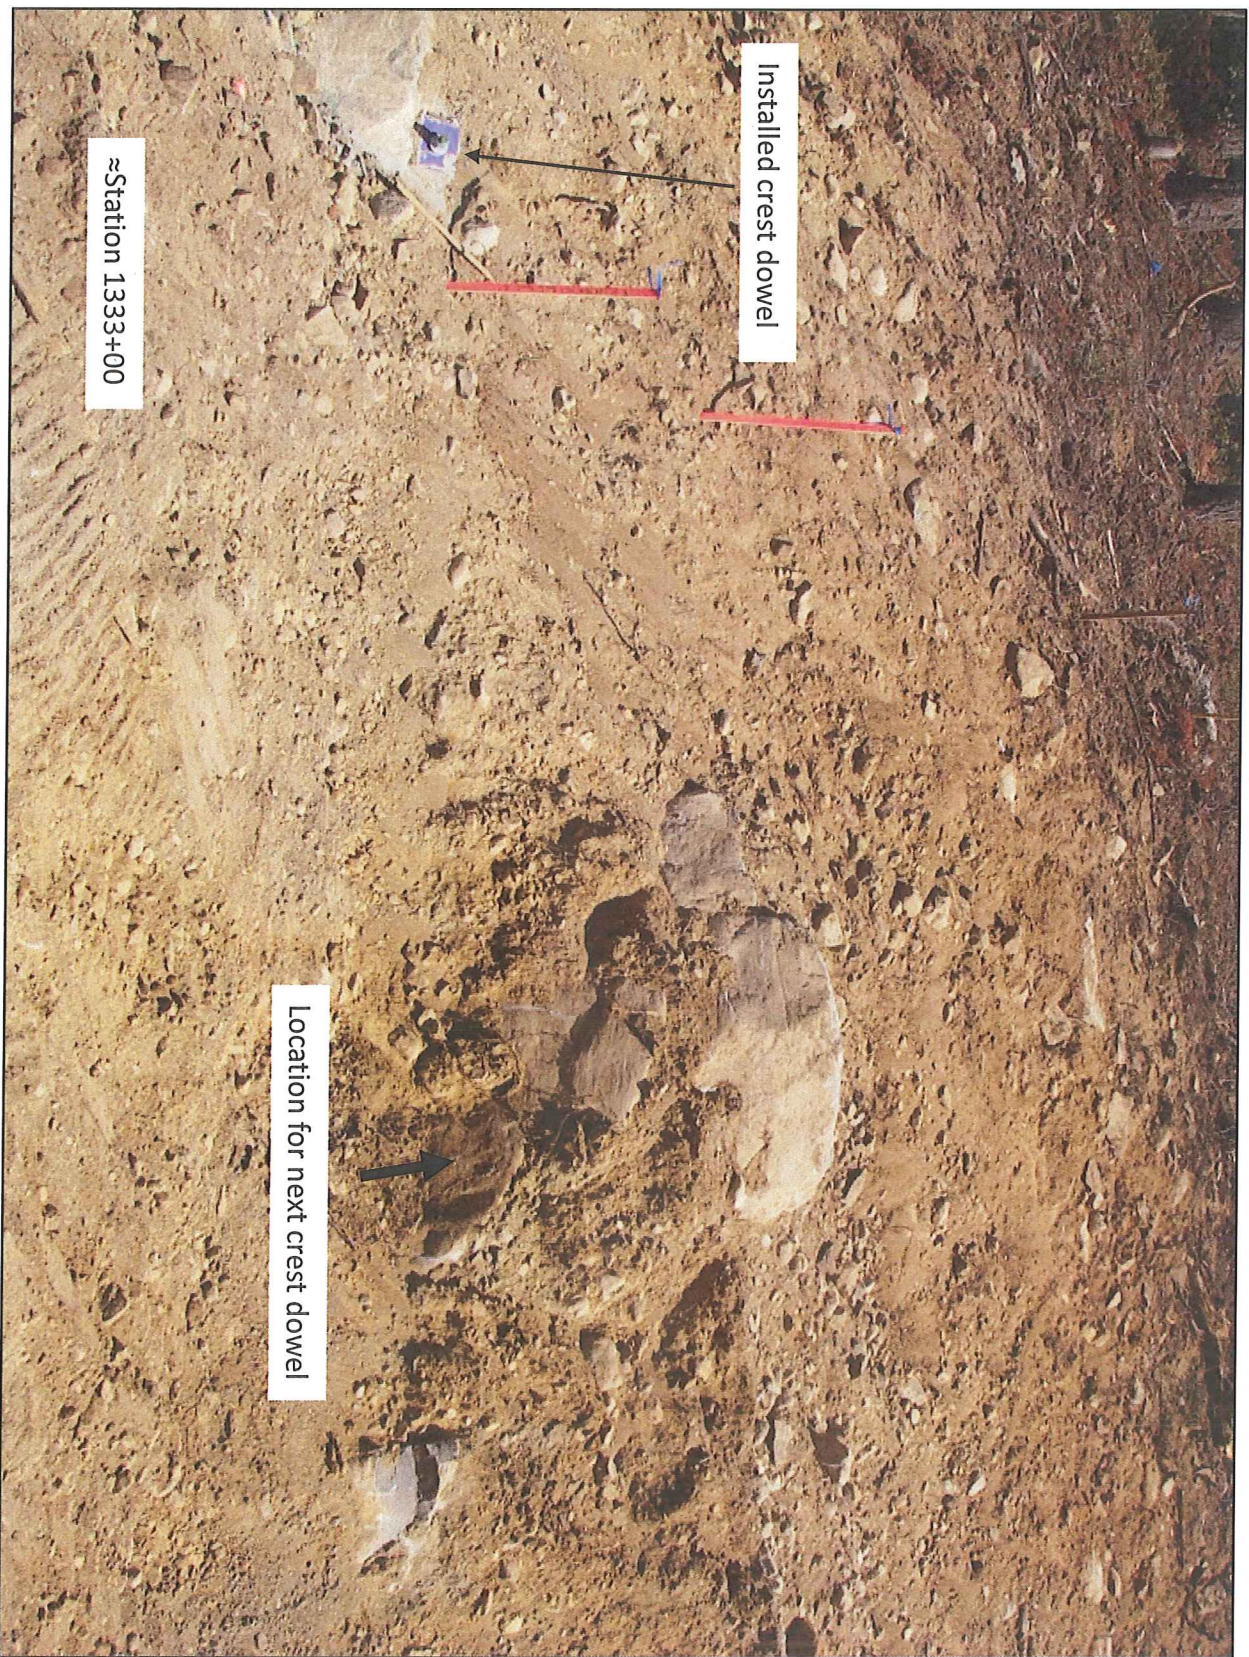
Brad Schut requested help marking crest dowel locations between Stations 1333+00 and 1333+50. He stated that the Contractor had excavated additional soil between these Stations as recommended (see Marc Fish IDR 8/12/10). After inspection, we were able to locate top-of-bedrock near Station 1333+15 and I informed Brad that a crest dowel could be marked at this location (Figure 2). Our inspection also revealed that one large apparent boulder (Station 1333+30) and overburden (Station 1333+50) still exist at locations where crest dowels still need to be installed (Figures 3 & 4). Once again I recommended that he use an excavator to remove the apparent boulder near Station 1333+30 and to excavate the soil to the top-of-bedrock near Station 1333+50.

Figure 2: Location for crest dowel near Station 1333+15.

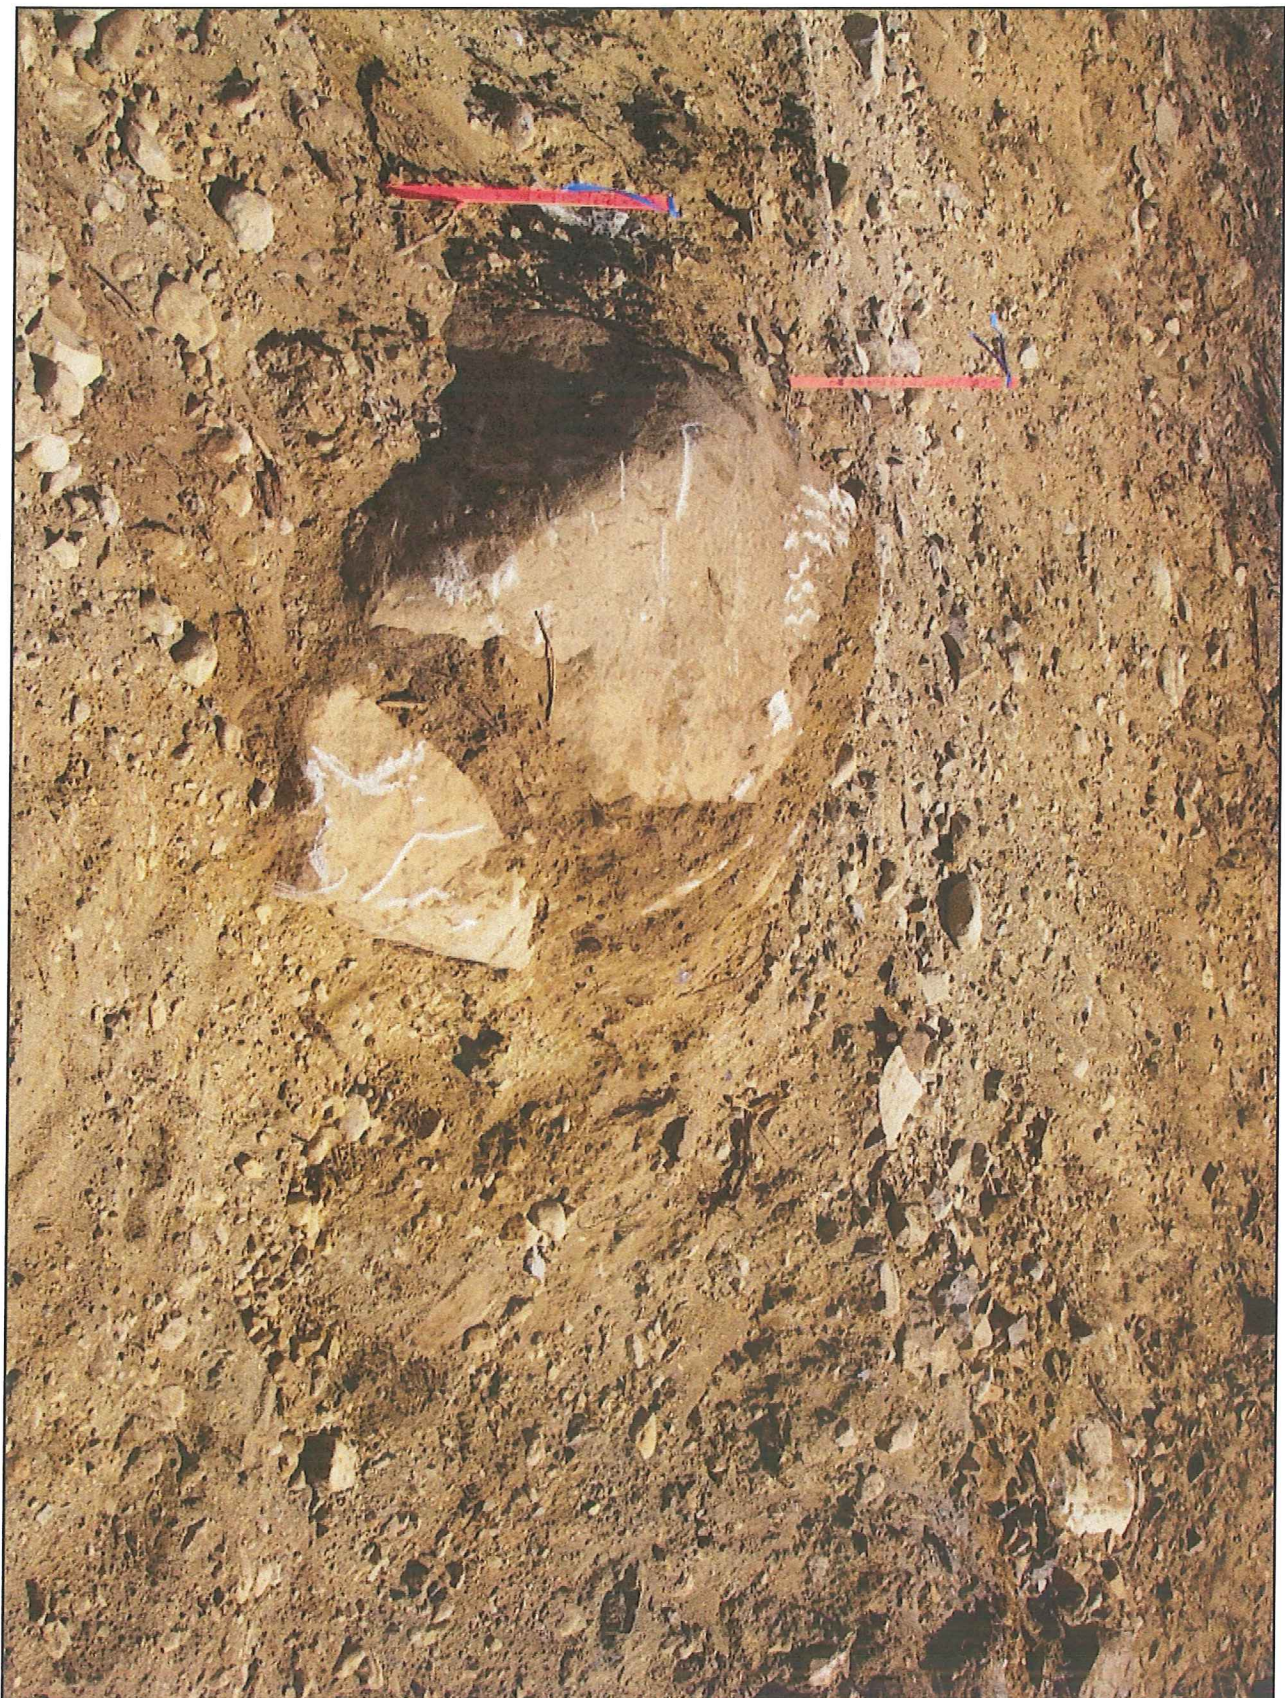
Figure 3: Large apparent boulder at the location for the next crest dowel, approximate Station 1333+30.

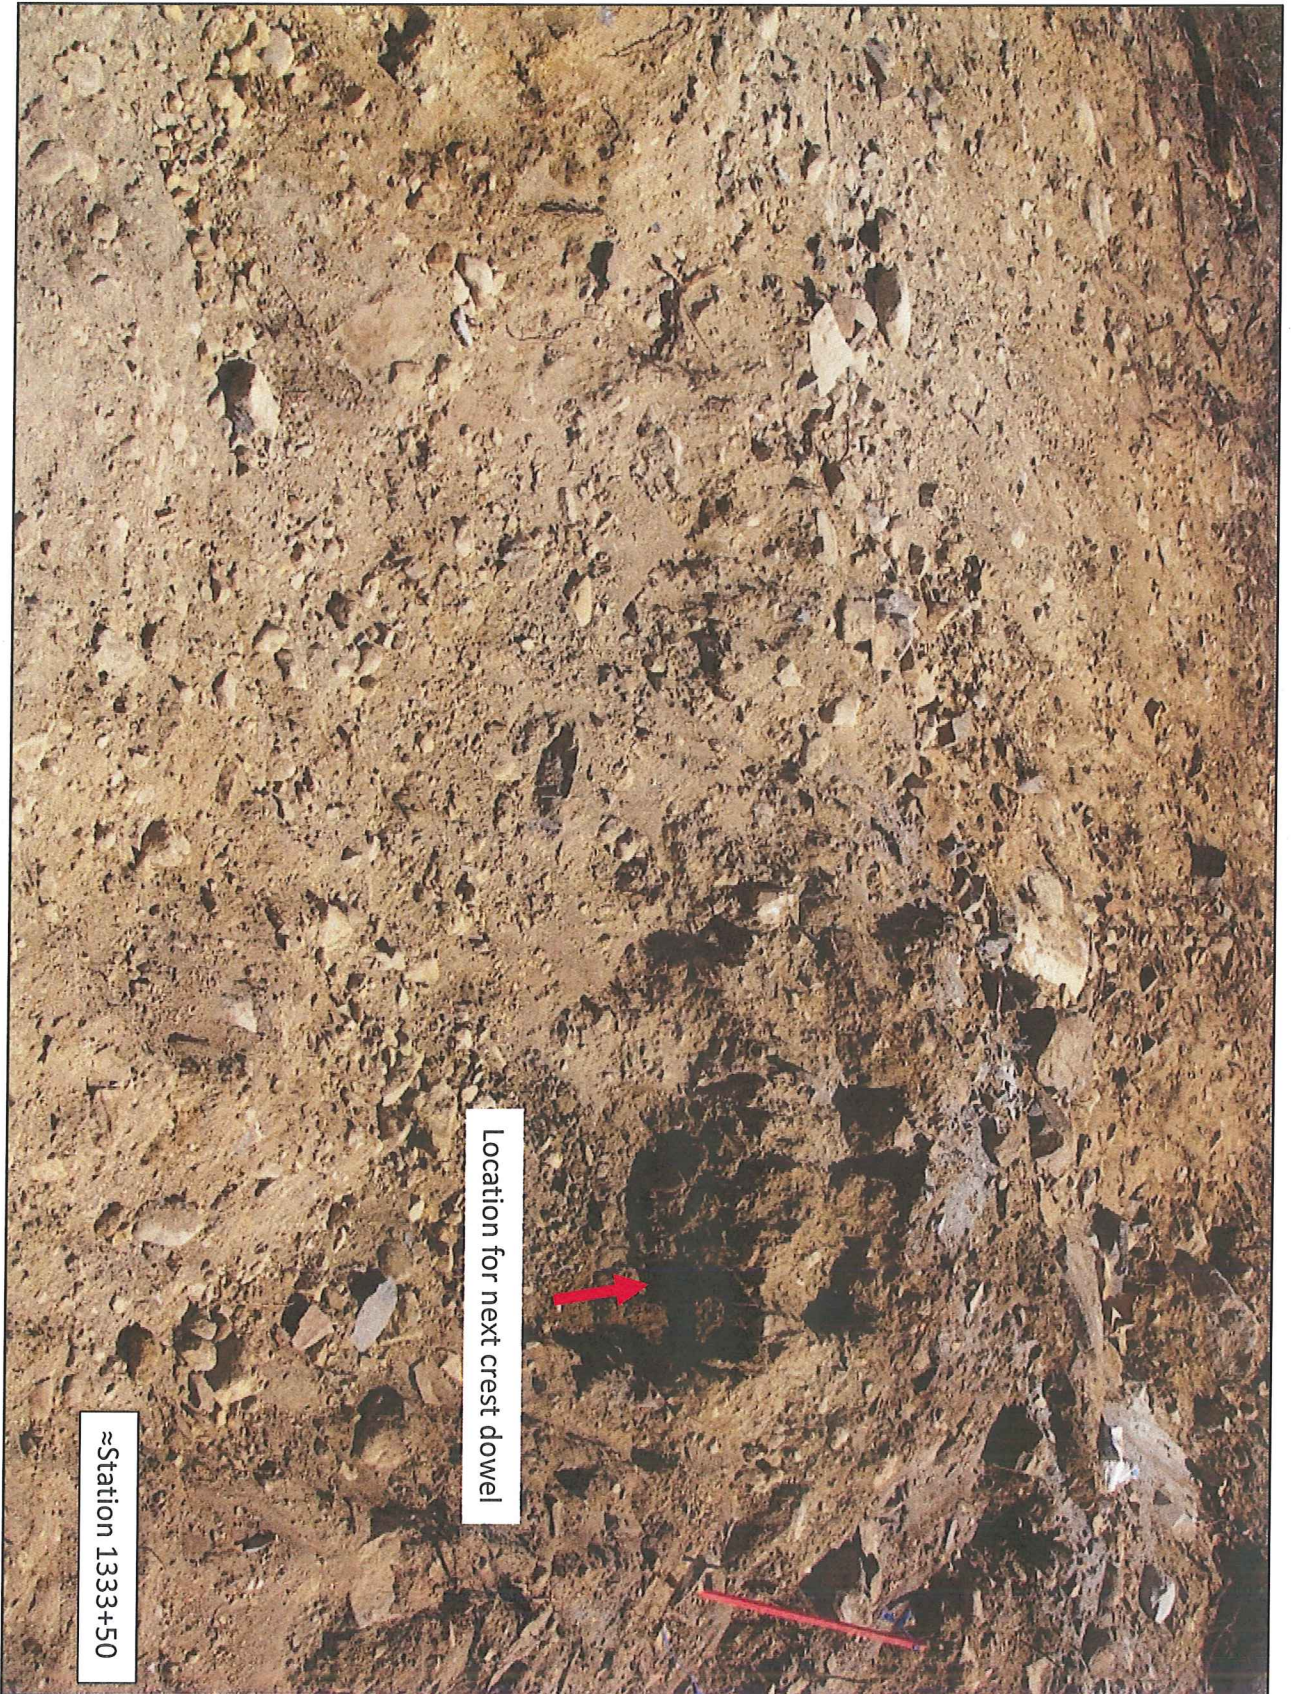
≈Station 1333+50

Figure 4: Overburden soil at location of next crest dowel, approximate Station 1333+50.
